SUBJECT Fuel Level Sensor Gives False Resistance Readings

MODEL E31, E32, E34, E36 (including Z3), E38, E39, E46, E52, E53

SUBJECT Stabilant 22A Electrical Contact Enhancer

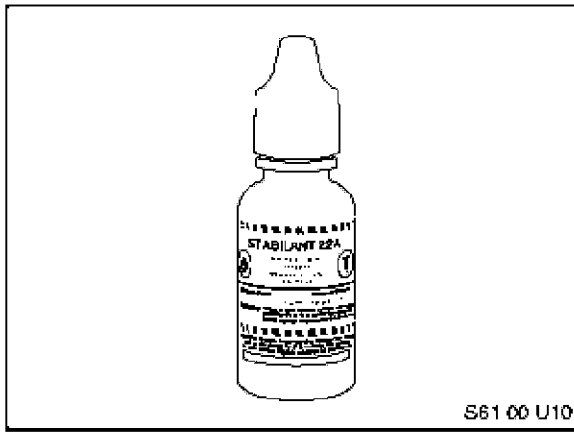
Stabilant 22A
